**DATE: 2/20/2020**

**INVESTIGATOR: Sam Capps**

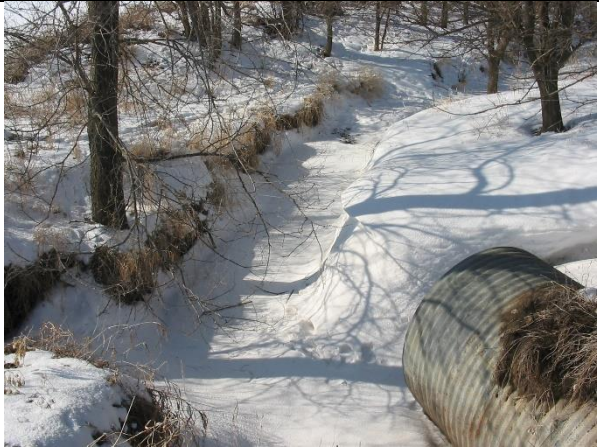
<p><b><u>STOP 1 – HIGHWAY 66 WEST of ASHLAND GUN CLUB</u></b></p> <p><b>Time:</b> 1430</p> <p>No change from previous reports.</p> <p>Camera malfunctioned and did not save the one photo taken at this stop. Observed same conditions as M. Lohnes 2/20/21am report.</p>	
<p><b><u>STOP 2 – North of the Intersection of COUNTY ROADS 6 &amp; F</u></b></p> <p><b>Time:</b> 1443</p> <p>No change from previous reports</p> <p>Photo facing up stream to the Northwest</p>

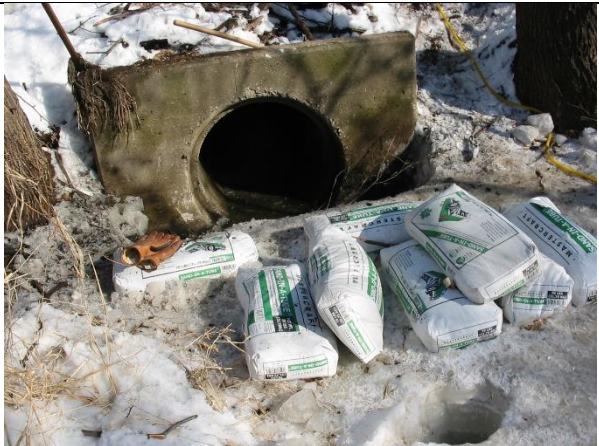
Photo: Entrance of culvert.

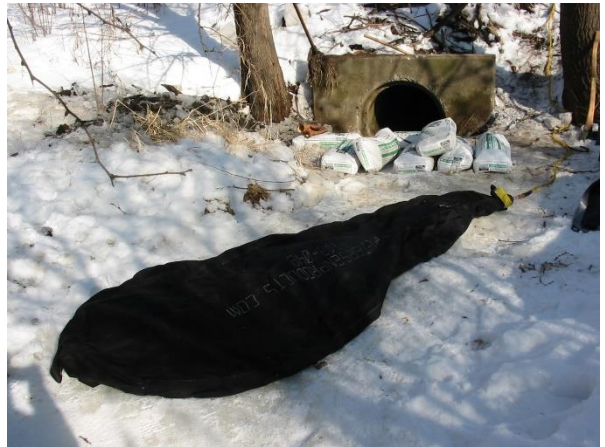
Photo: Taken upslope from culvert

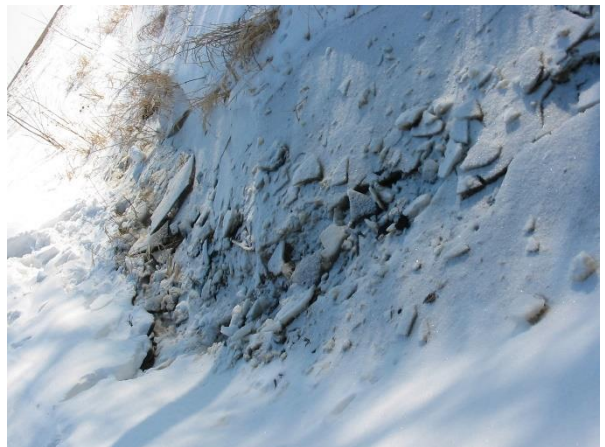
Photo: Ice beginning to thaw. Facing upstream.

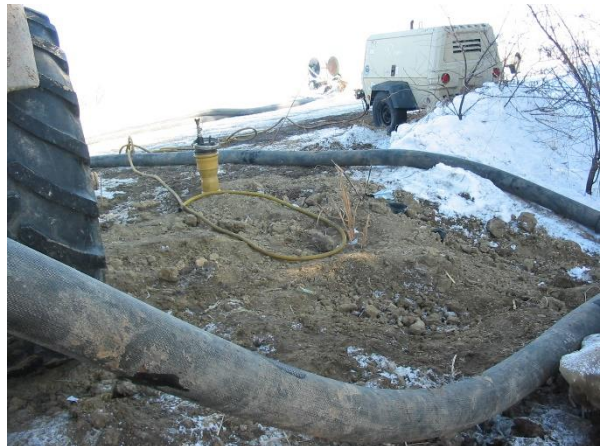
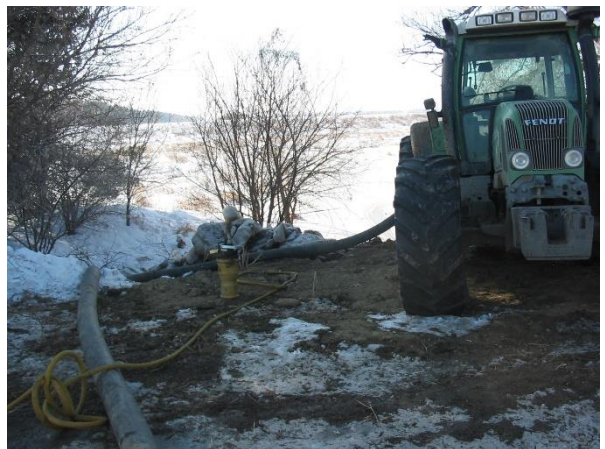
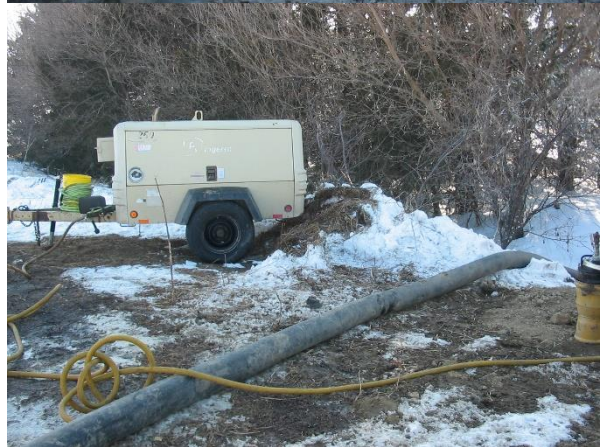
Odor present. Pumping did not appear to be occurring at the time of visit. Tractor, backhoe, and pump on site.

Photos: Various angles showing set up for to complete pumping.

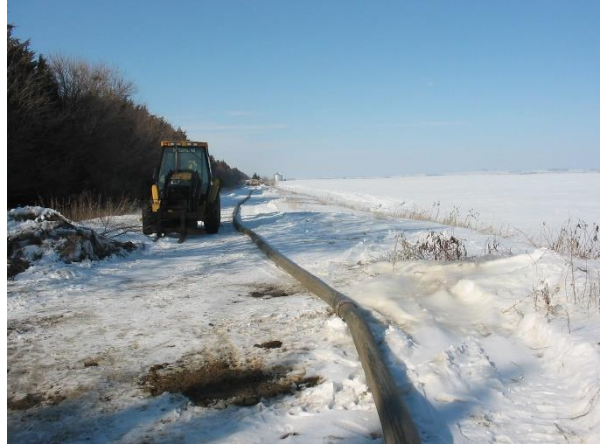
Photo: Hose laid to the north. Terracon said that it went to AltEn lagoon.

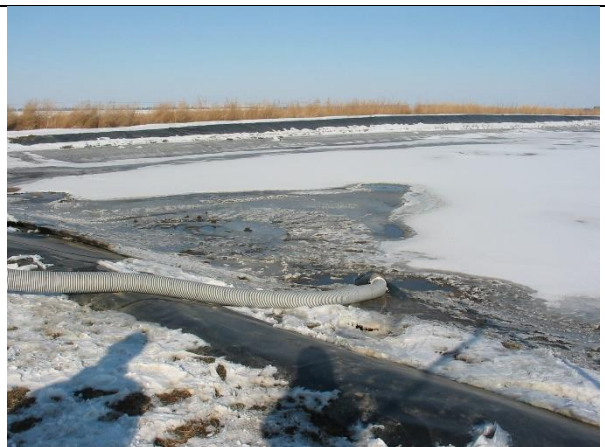
Photo: Hose pumping out of emergency lagoon.

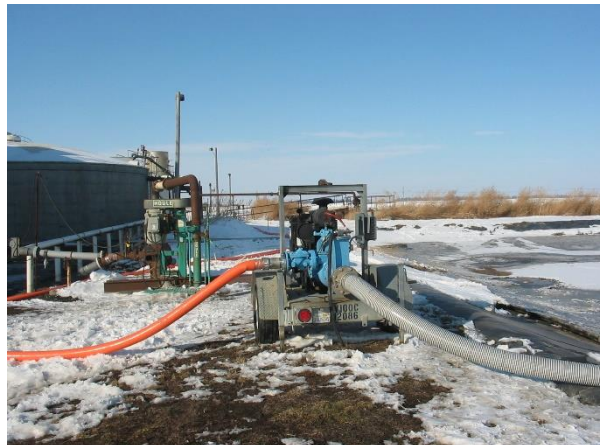
Photo: Pump at emergency lagoon.

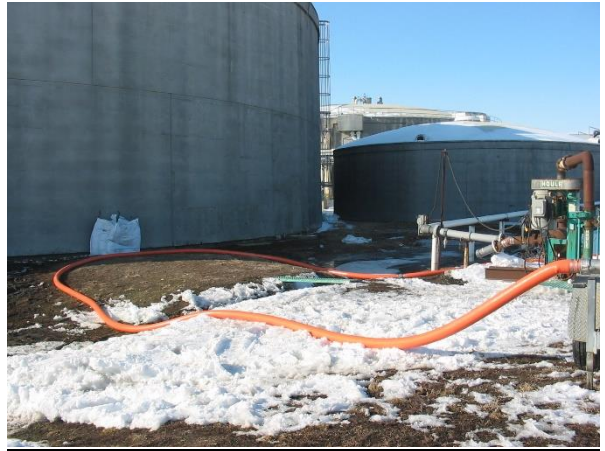
Photo: Hose coming off of pump.

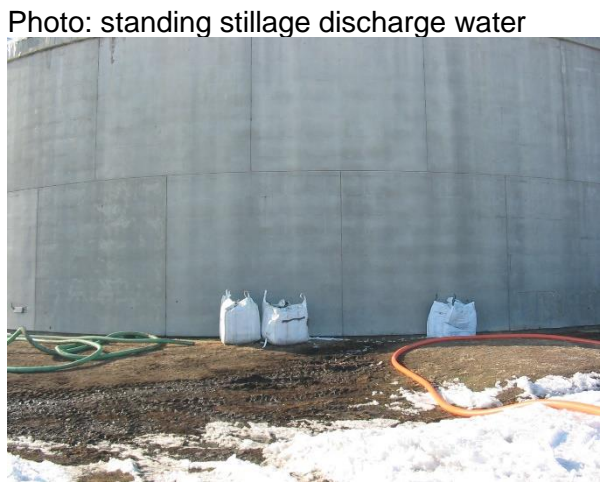
Photo: Area near Digester 1

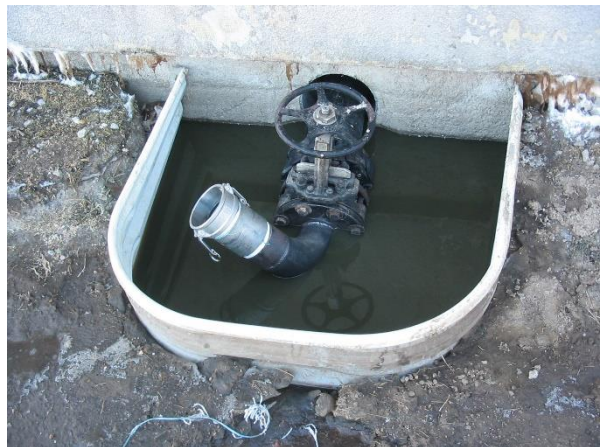
Photo: Digester 1 pipe/valve with standing stillage discharge water.

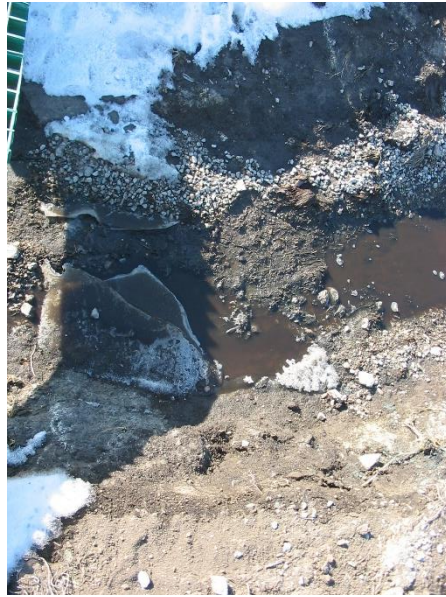
Photo: Standing stillage discharge water on ground between Digester 1 and Digester 2

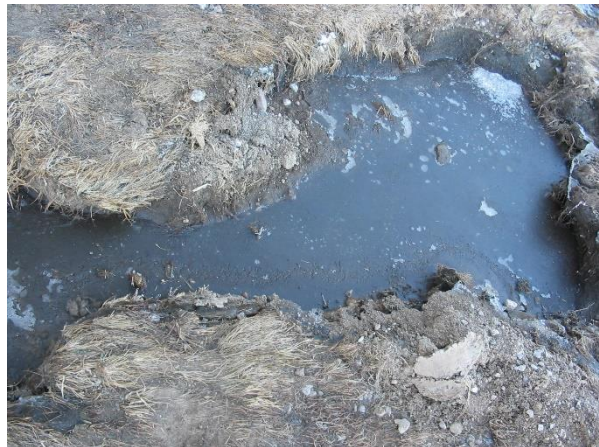
Photo: More standing stillage discharge water on ground between Digester 1 and Digester 2

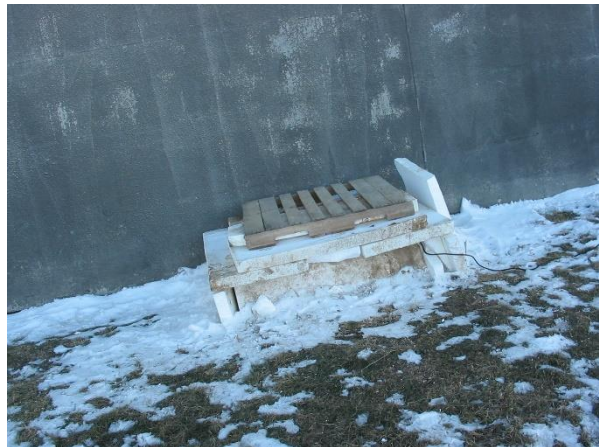
Photo: Covered pipe/valve on Digester 2

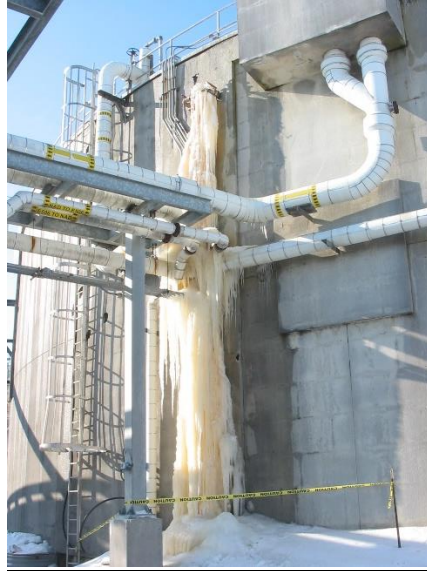
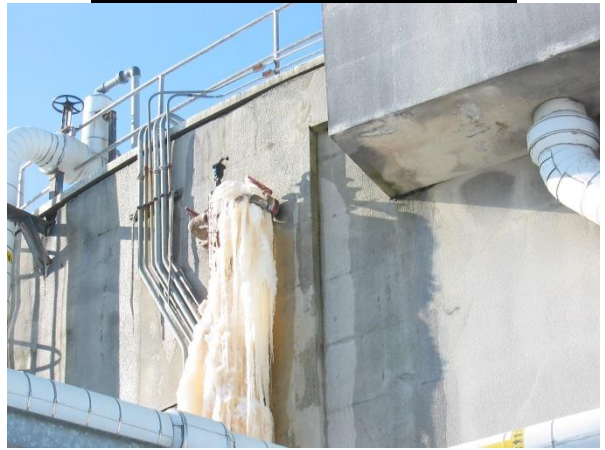
Photos: Continuous leak on Digester 2

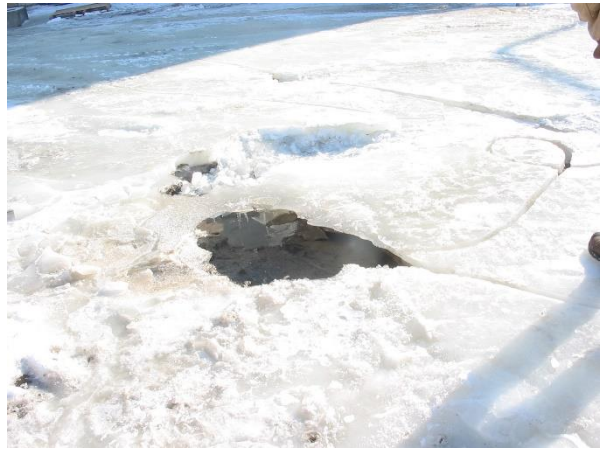
Photo: Area behind Digester 2 with significant ice build up. Several inches thick.

Large area behind Digester 2 was observed while walking to the road to leave site. Ice was several inches thick. It had large cracks and holes because of thawing. Ken Peterson said that all of the ice was from the initial release of stillage discharge water.
